# DEVELOPMENT, TESTING AND EVALUATION OF MHD-MATERIALS

Quarterly Report

for the period October - December 1976

H. P. R. Frederikse, T. Negas and S. J. Schneider

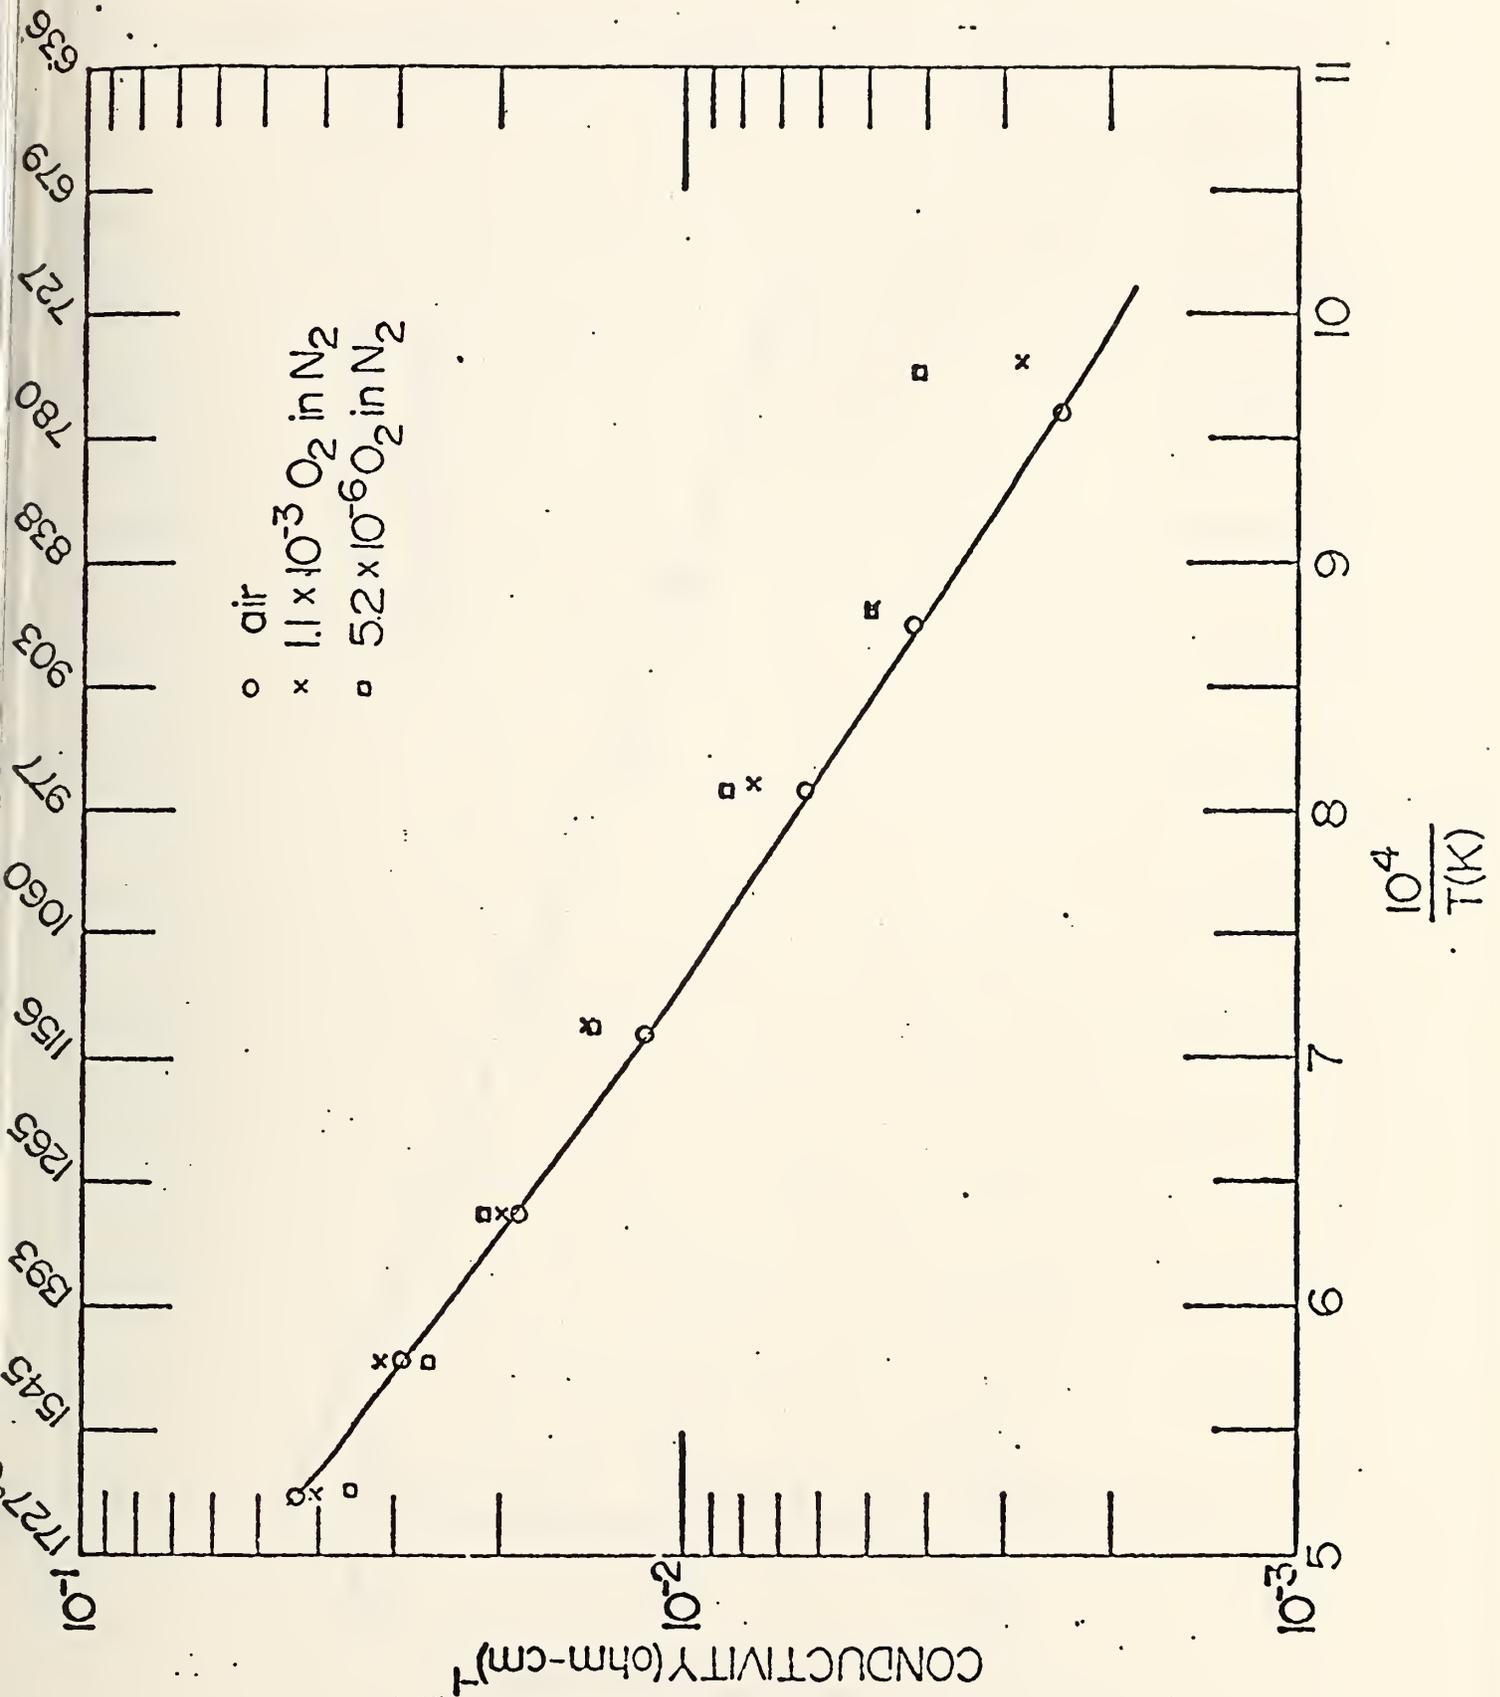
Fig. 3. Electrical conductivity of MAFF 91 ( $90\text{MgAl}_2\text{O}_4-10\text{Fe}_3\text{O}_4$ ) as a function of temperature at several partial pressures of  $\text{O}_2$ . Material prepared by Trans Tech Inc. and is 82.7% dense.

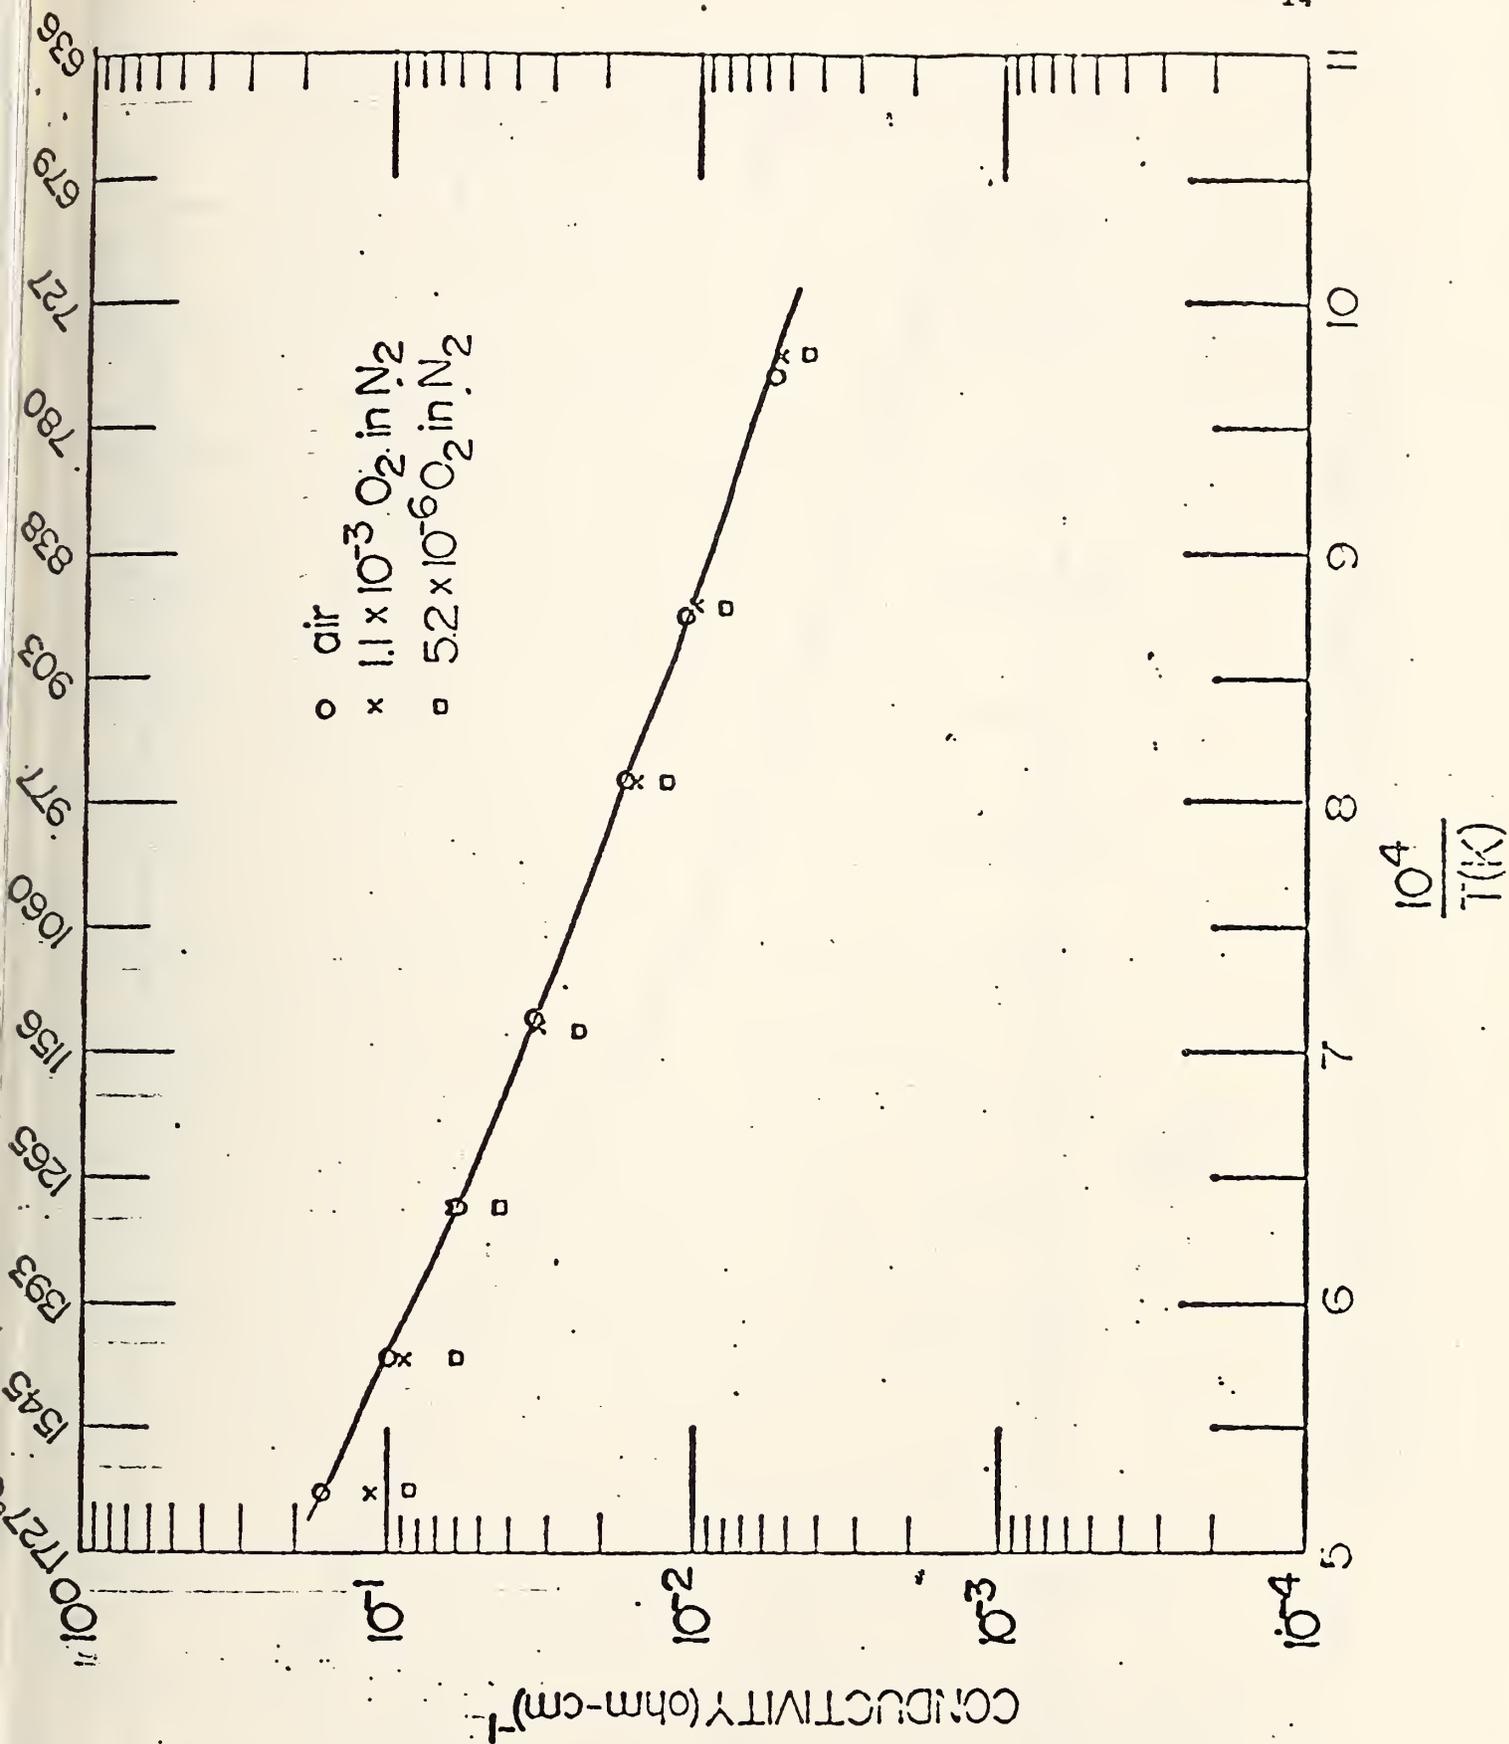
Fig. 4. Electrical conductivity of MAFF 61 ( $85\text{MgAl}_2\text{O}_4-15\text{Fe}_3\text{O}_4$ ) as a function of temperature at several partial pressures of oxygen. Material prepared at NBS and is ~80% dense.

The conductivity of a sample of MAFF-61 ( $6\text{MgAl}_2\text{O}_4-1\text{Fe}_3\text{O}_4$ ), presented in Fig. 4 are somewhat better in this respect. Again, the density of this particular material is only around 80%: Less porous samples may show an appreciably higher conductivity.

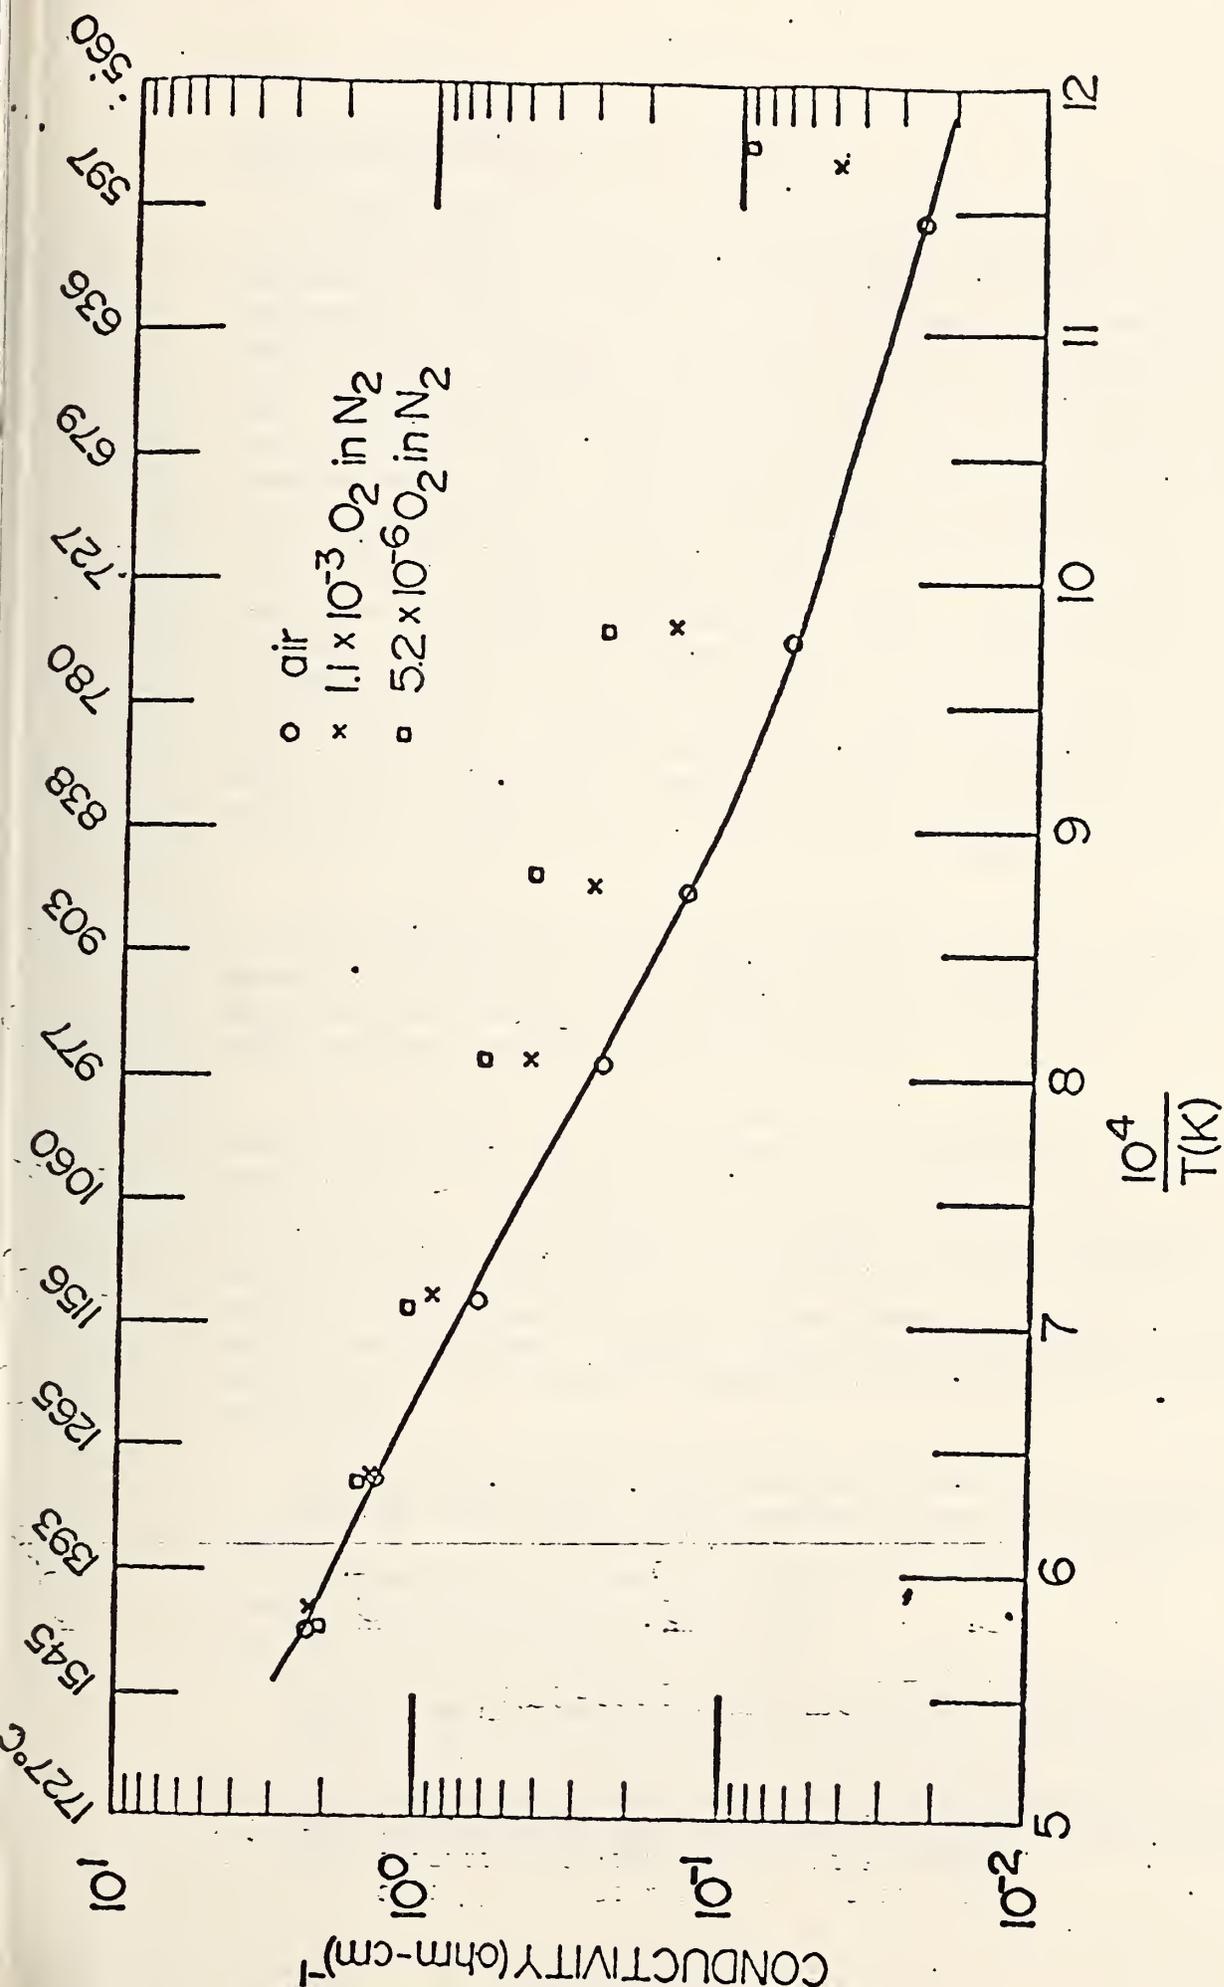
Figure 5. Electrical conductivity of approximately 11 Ni(FeAl)<sub>0.4</sub>-1 MnAl<sub>2</sub>O<sub>4</sub> as a function of temperature for several partial pressures of oxygen. Material prepared by Trans Tech Inc.

The third sample is a solid solution of  $11\text{Ni}(\text{FeAl})\text{O}_4$  and  $1\text{MnAl}_2\text{O}_4$  (according to the manufacturer). The conductivity of this material (MAFF-11) (see Fig. 5 ) is very similar to that of MAFF 31.

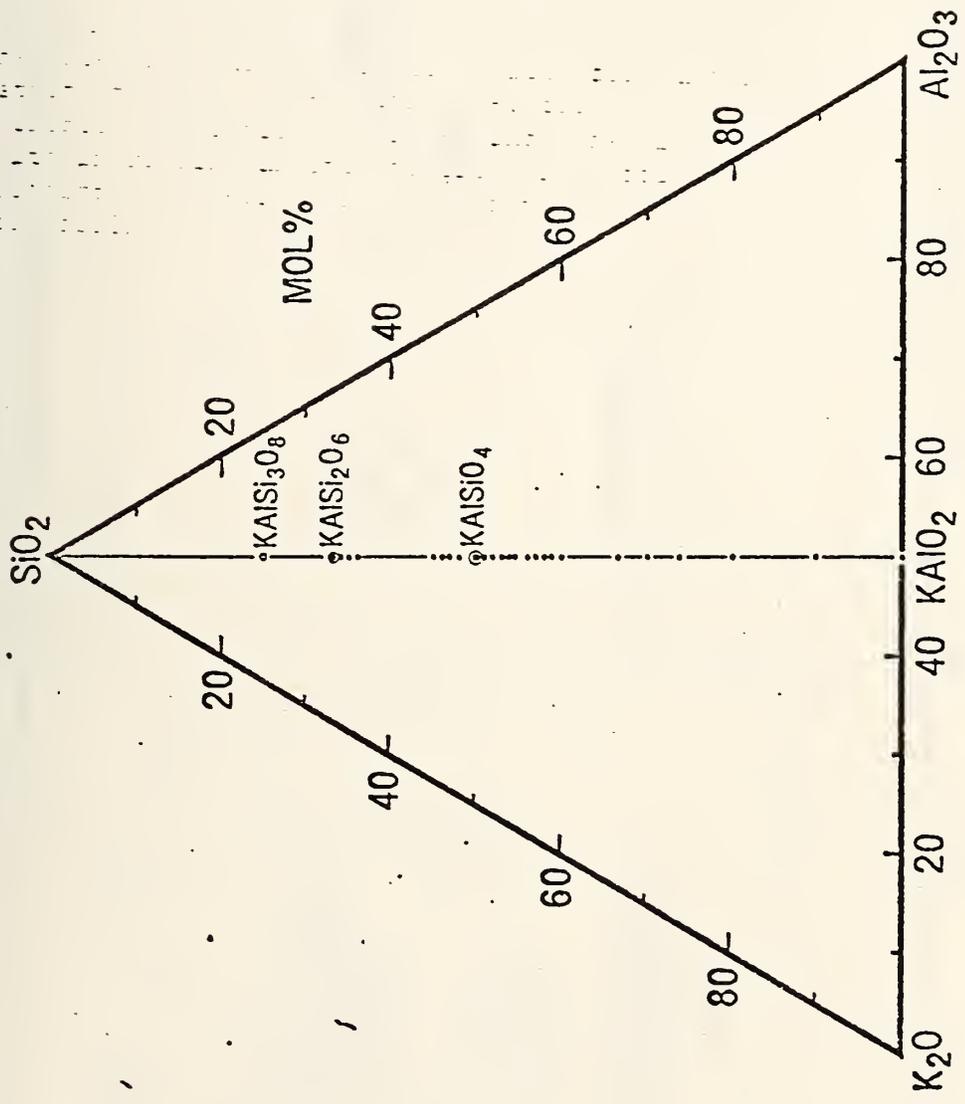
Fig. 1. K-Al-Si compounds in the ternary Phase diagram of the system  $K_2O-SiO_2-Al_2O_3$

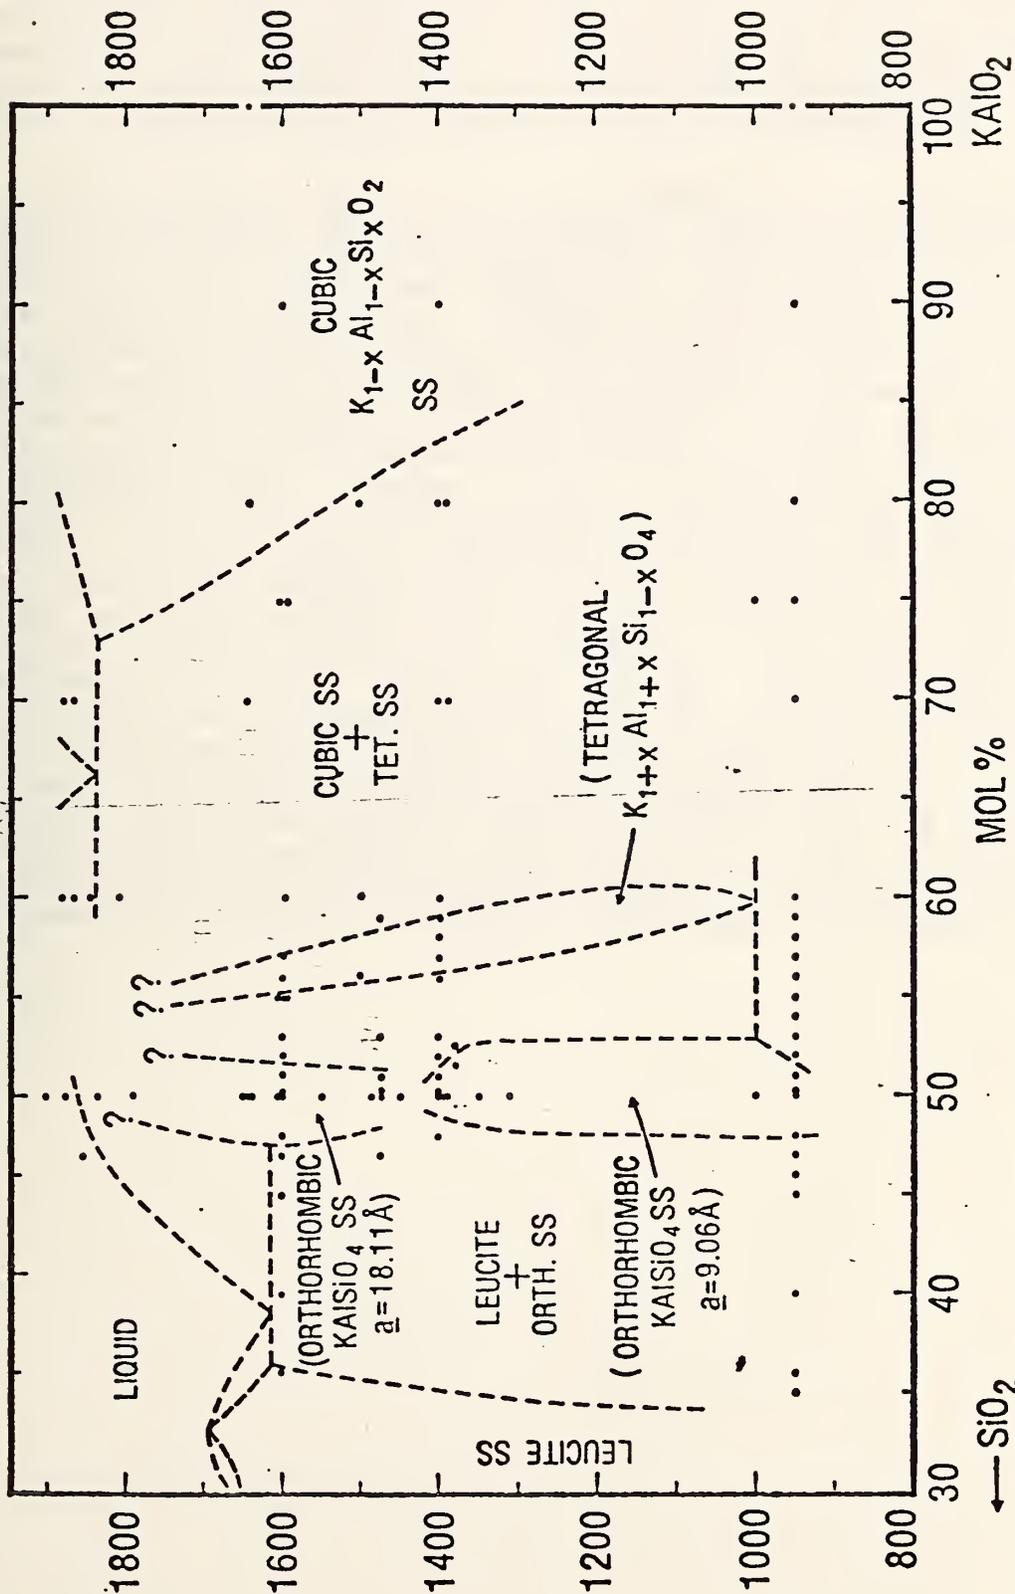
Fig. 2. Schematic phase diagram of the system  $\text{SiO}_2$ - $\text{KAlO}_2$  (<30 m/o  $\text{SiO}_2$ )

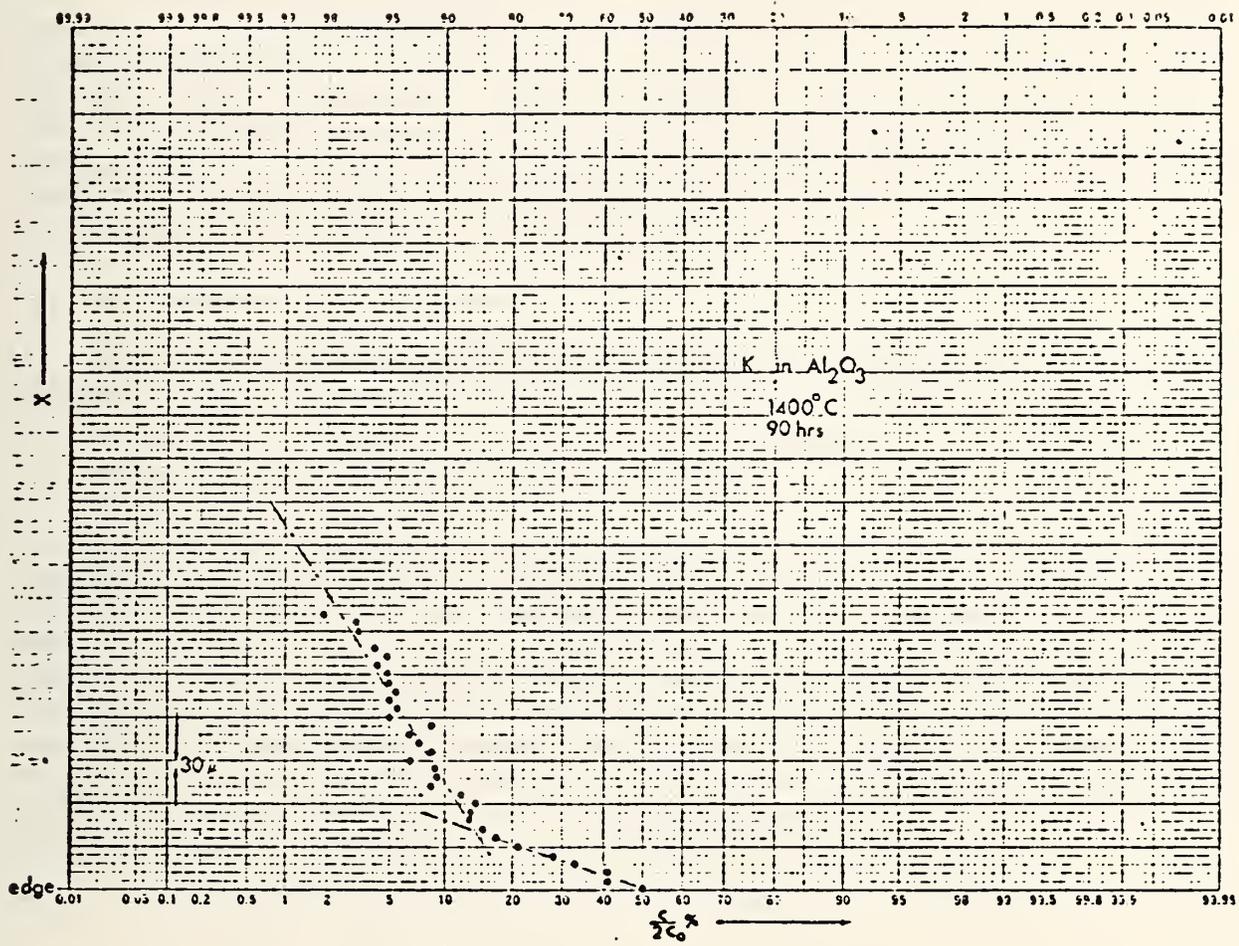
Figure 3. K concentration plotted on probability paper.

X = distance from the surface in 30 $\mu$  units.  
C = concentration at X.  
C<sub>0</sub> = concentration of K at surface.

Thus, by determining  $C$ , the concentration as a function of  $X$ , the penetration into the ceramic, the value of  $D$  can be determined for known diffusion times at a specific temperature. The concentration profile of potassium in  $\text{Al}_2\text{O}_3$  (90% dense) diffused at 1400 °C for 90 hrs. was determined using an electron probe. Because of the porosity of the  $\text{Al}_2\text{O}_3$ , data were collected by scanning along a strip parallel to the edge of specimen and then moving into the interior of the specimen and scanning again. This method has been described in earlier reports. A 10  $\mu\text{m}$  beam was used and data were collected at intervals of 30  $\mu\text{m}$  from the edge. The data, as plotted on probability paper, is shown in Fig. 3. Data which fit the error function expression given above yield a straight line when plotted on probability paper. In Fig. 3, we see there are essentially two straight line segments. One which ends  $\sim 200 \mu$  from the surface and the second which begins there and continues to the end of the collected data. The first straight line segment yields a diffusion coefficient of  $5.7 \times 10^{-10} \text{ cm}^2/\text{sec}$ . The second yields a diffusion coefficient of  $\sim 1 \times 10^{-8} \text{ cm}^2/\text{sec}$  (at 1400 °C). The first diffusion coefficient would seem to be characteristic of a volume diffusion through the  $\text{Al}_2\text{O}_3$  grains while the second region could well represent a predominately grain boundary diffusion at a much faster rate. The data representing the volume diffusion has much less scatter than that which represents the faster rate which suggests that the K is not penetrating as uniformly in the faster diffusion region. The measurement of these diffusion coefficients of potassium into  $\text{Al}_2\text{O}_3$  ceramic represents achievement of a milestone under Task J (Corrosion and Diffusion).

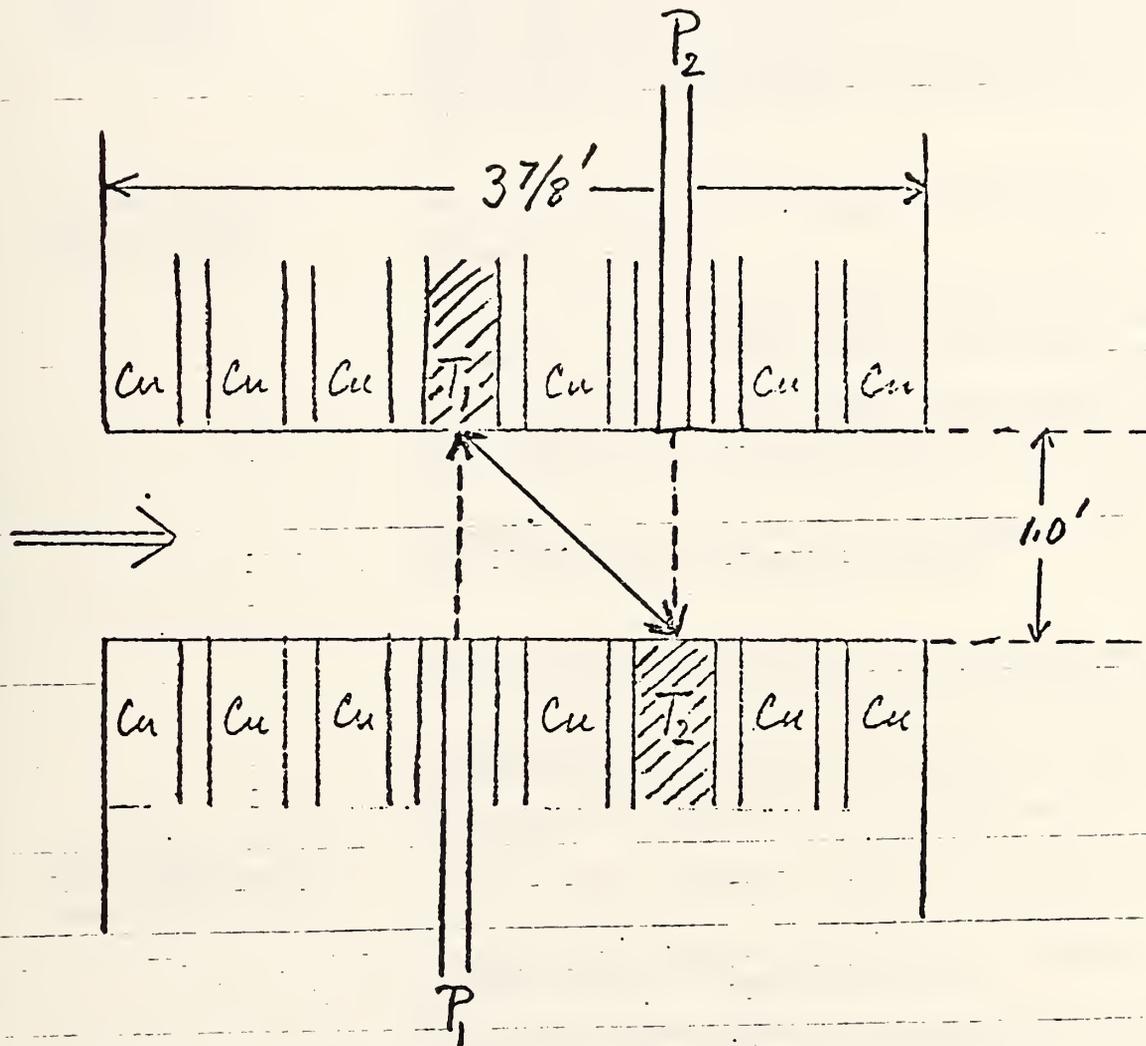
FIG. 1. Reynolds Test Rig.

The Reynolds test rig (see Fig. 1) is a small 4" long channel fueled with propyl alcohol. Both electrode walls contain 8 electrodes (3/8" wide); on the anode side, the test electrode is No. 4 (T<sub>1</sub>) and on the cathode side No. 6 (T<sub>2</sub>). (See Fig. 1). The other electrodes are bare copper. The facility has no magnet. The surface temperatures of each of the test electrodes is measured with pyrometers (P<sub>1</sub> and P<sub>2</sub>). This way the state of the surface can be observed directly and continuously (visible area cross section ~3/16"). Other quantities measured are the temperature of the cooling water (which indicates the heat flux) as well as the applied cross voltages and interelectrode potentials.

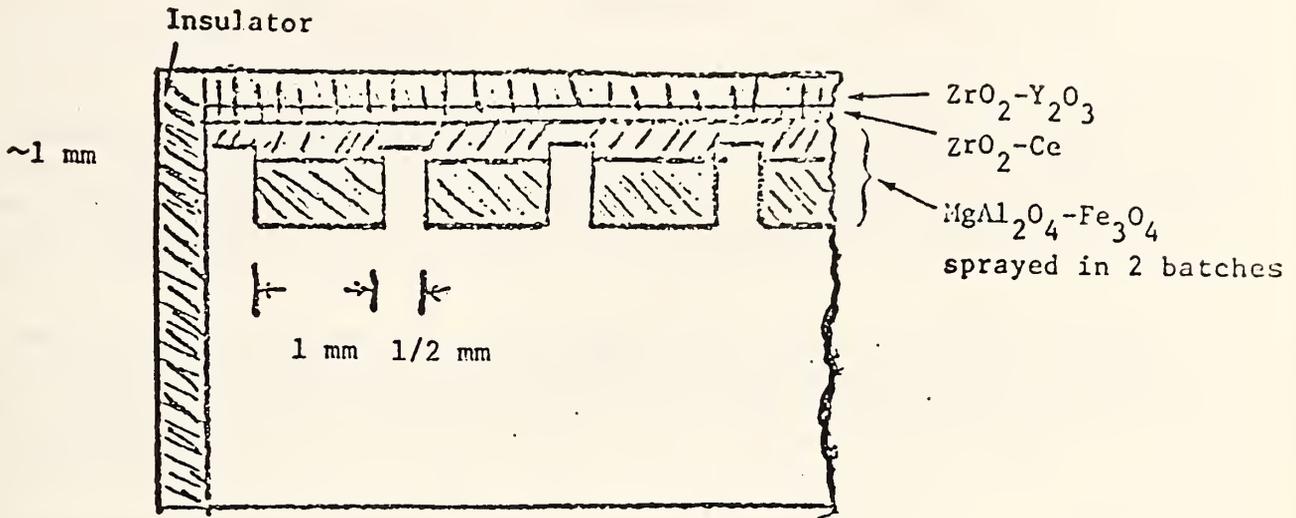
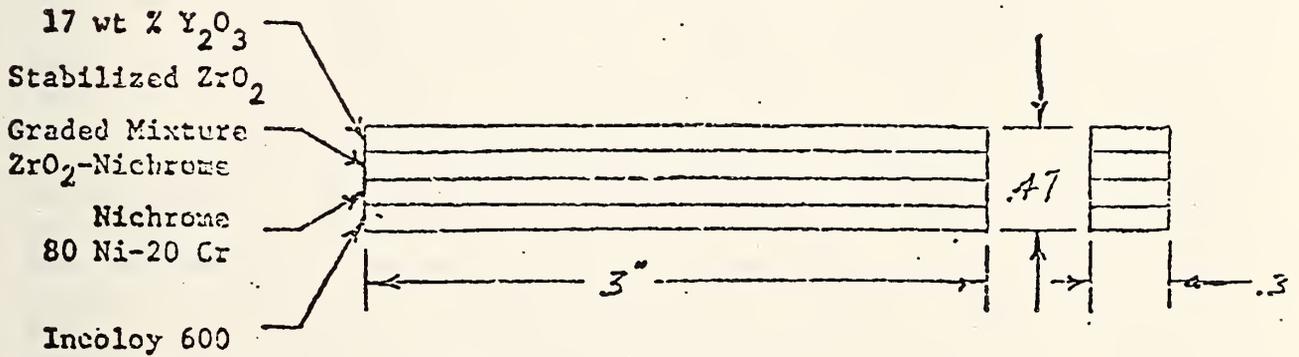
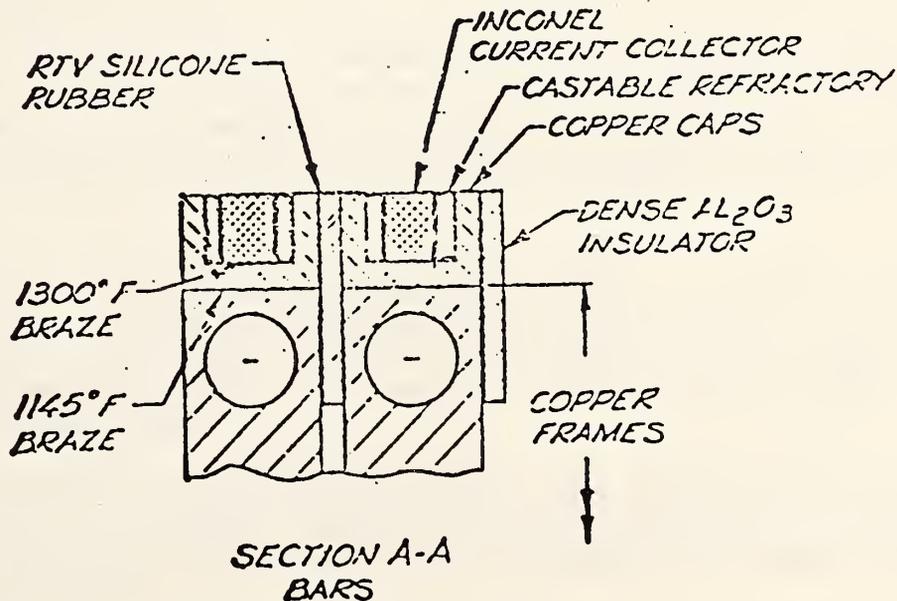
Figure 2. Sketch of electrodes tested in Tests 3,4, and 5 of the ANL/Reynolds program.

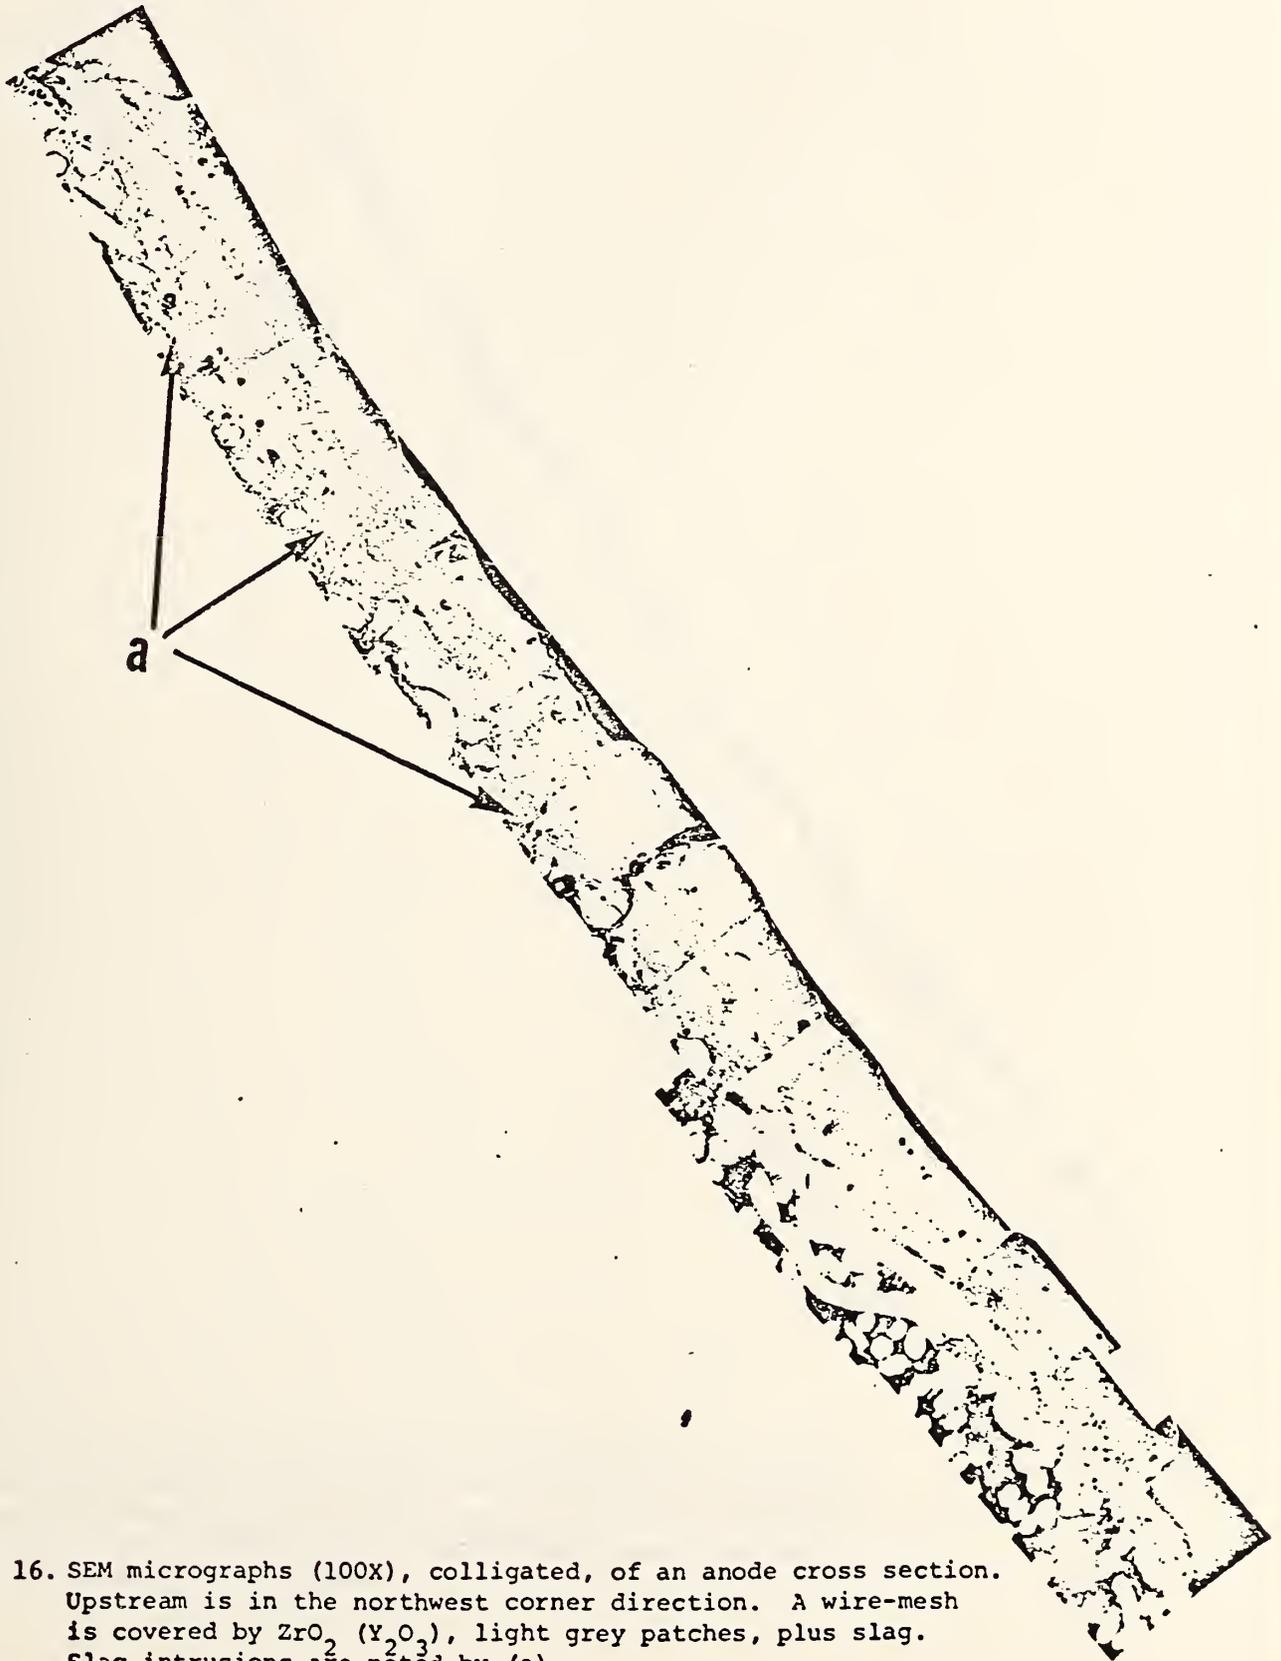
Fig. 16. SEM micrographs (100X), colligated, of an anode cross section. Upstream is in the northwest corner direction. A wire-mesh is covered by  $ZrO_2$  ( $Y_2O_3$ ), light grey patches, plus slag. Slag intrusions are noted by (a).

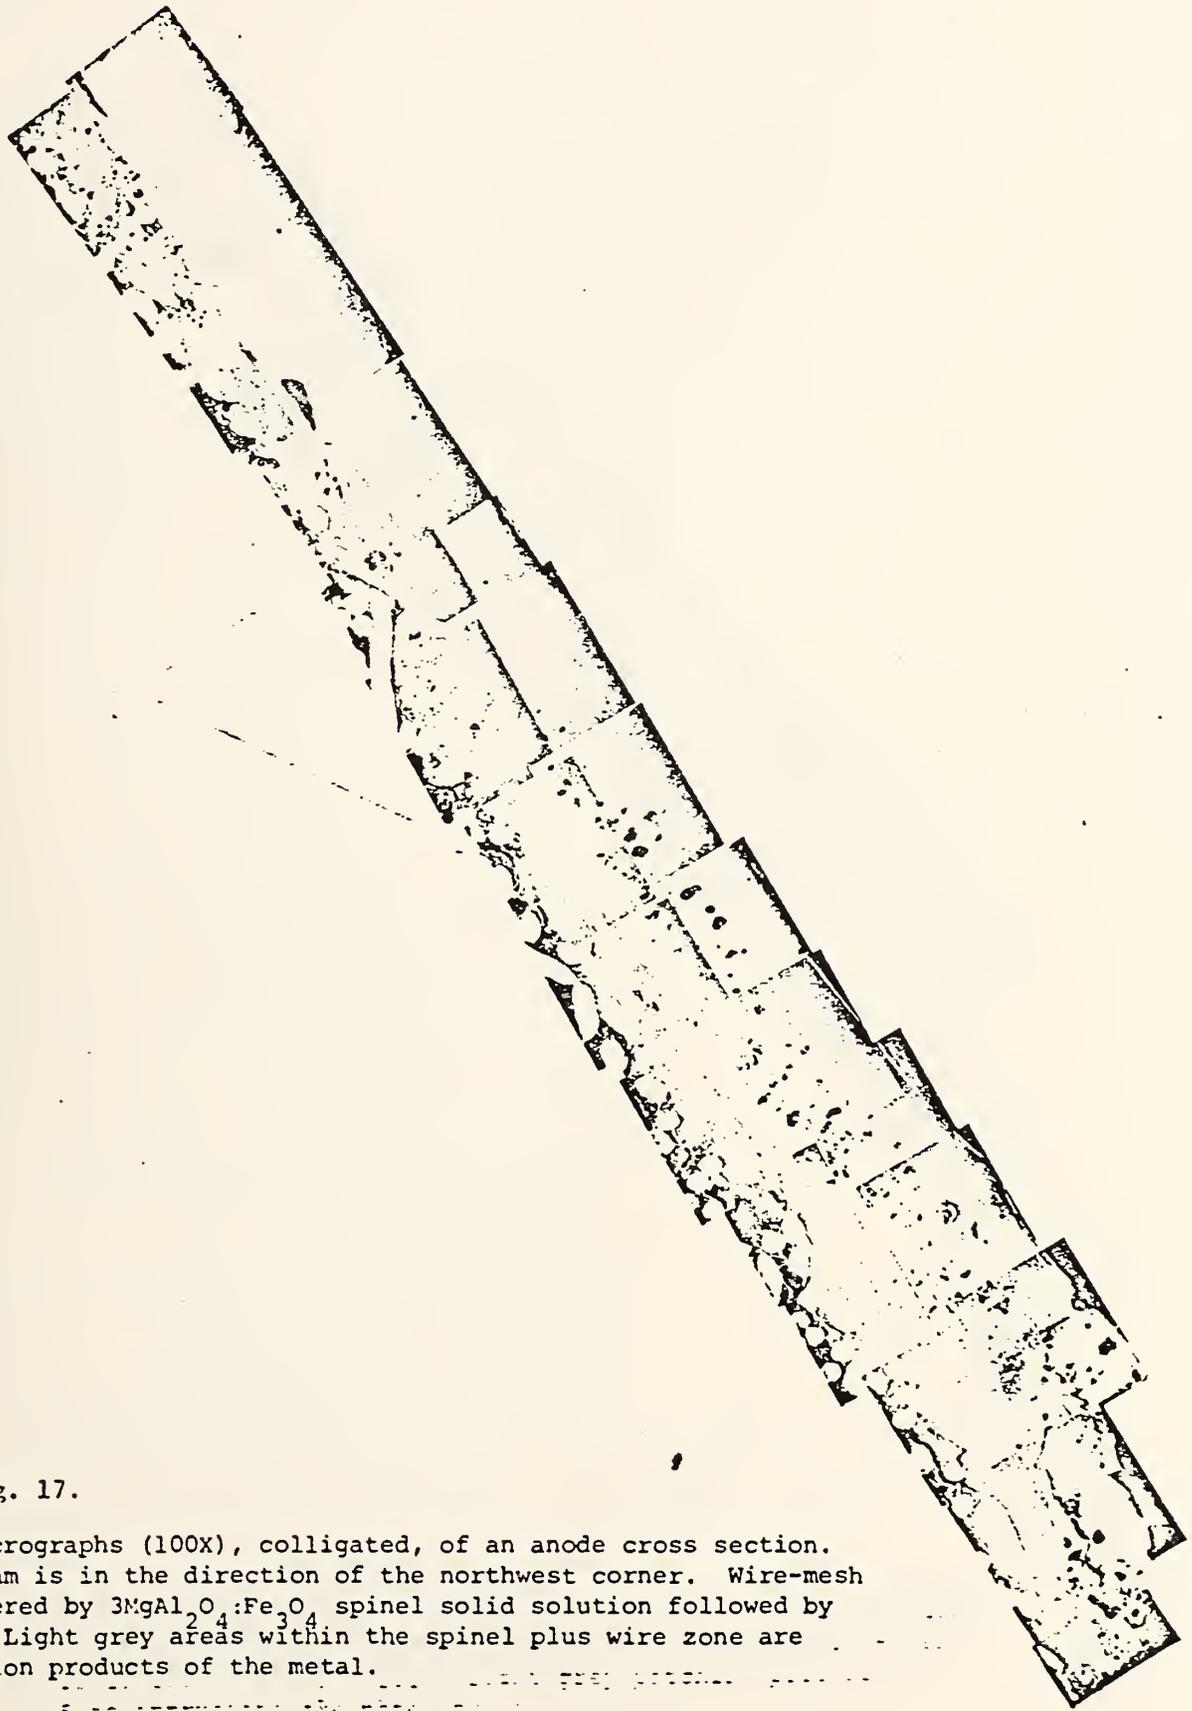
Fig. 17.

SEM micrographs (100X), colligated, of an anode cross section. Upstream is in the direction of the northwest corner. Wire-mesh is covered by  $3\text{MgAl}_2\text{O}_4:\text{Fe}_3\text{O}_4$  spinel solid solution followed by slag. Light grey areas within the spinel plus wire zone are oxidation products of the metal.

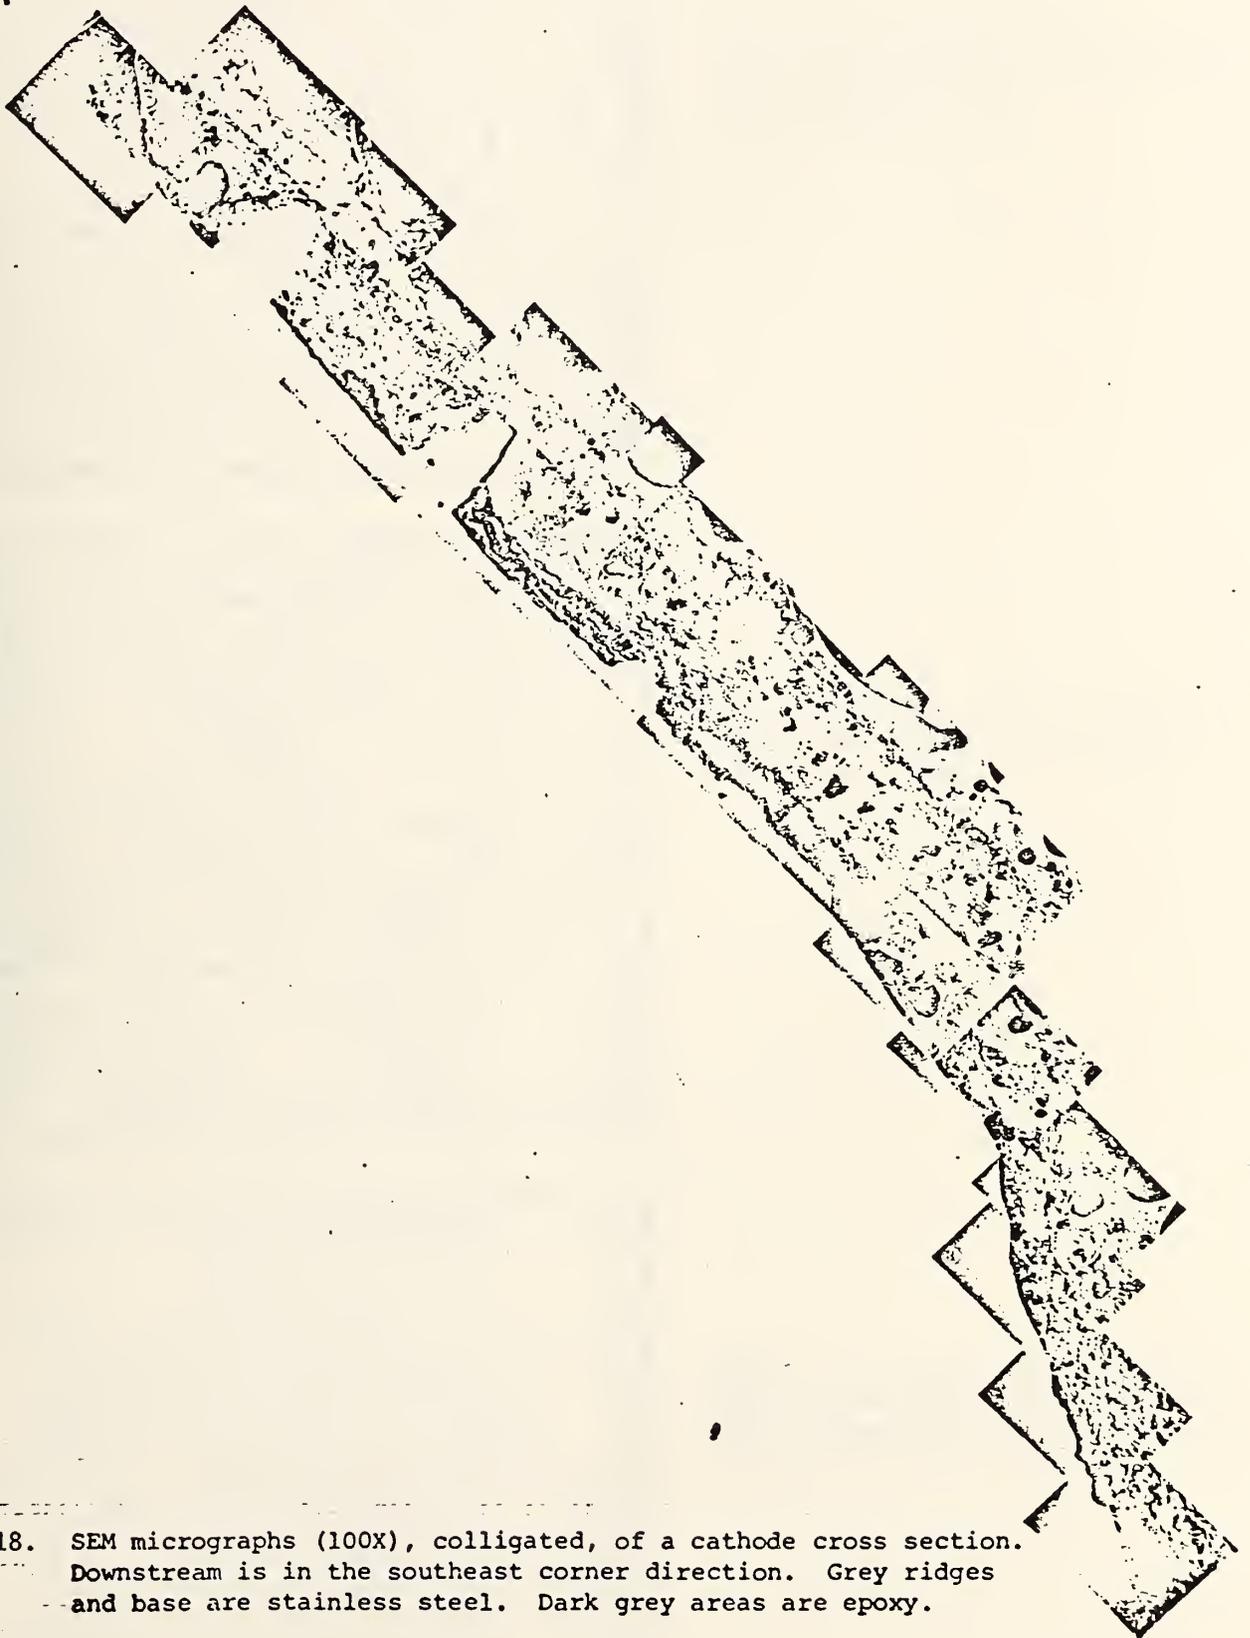
Fig. 18. SEM micrographs (100X), colligated, of a cathode cross section. Downstream is in the southeast corner direction. Grey ridges and base are stainless steel. Dark grey areas are epoxy.

We also received a cathode operated for 30 hr with slag/seed. It consisted, originally, of stainless steel having a ridge and groove surface onto which a coating of an Fe-Al-oxide spinel (composition unknown) was applied. Fig. 18 (100X) illustrates a typical cross-section. Higher magnification micrographs and EDX data are available. A flat polished surface could not be maintained (shown by the irregularities in Fig. 18) as the electrode was saturated by potassium salts which hydrated and "bled" during handling.

The electrode apparently suffered from excessive heating particularly at the downstream end (right side) wherein the stainless steel suffered extensive recession via oxidation. The remaining stainless steel pins (grey) on the upstream side also are being subjected to oxidation but at a slower rate. Oxidation products (Fe/Ni/Cr-oxides) surround these pins. Slag components including K have replaced entirely the pre-existing spinel ceramic. Dark grey areas between the stainless and slag and the zones containing "bubbles" above the slag consist of epoxy.

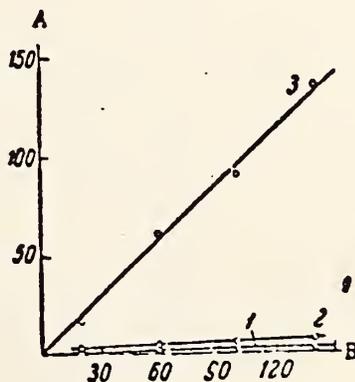
Corrosion of Fe in different chlorides at temperatures 70°C above the melting point of the chloride.

A) Corrosion activity K (in g/m<sup>2</sup>).

B) time  $\tau$  (in minutes).

Curves: 1) NaCl; 2) KCl; 3)  $CaCl_2$ .

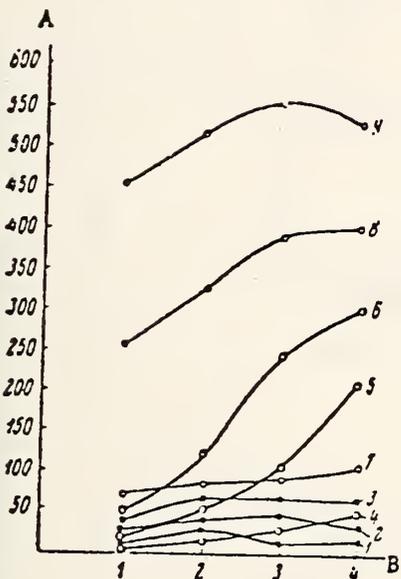
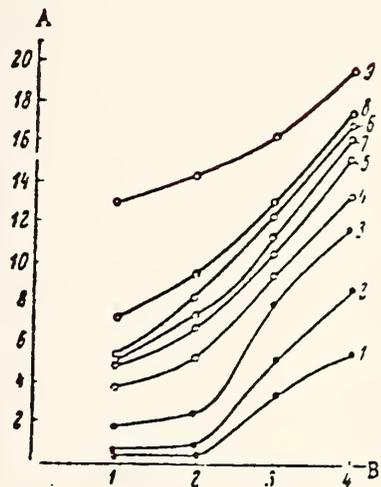
(a) Isotherms for corrosion in fused KOH: A) corrosion (in  $\text{g}/\text{m}^2$ ); B) duration of experiment (hours); nickel: 1) 500°; 2) 450°; 3) 400°; Kh18N9T steel: 4) 400°; 5) 450°; 6) 500°; "Armco" Iron: 7) 500°; 8) 400°; 9) 450°.

(b) Isotherms for corrosion in fused NaOH: A) corrosion (in  $\text{mg}/\text{m}^2$ ); B) duration of experiment (hours). Nickel: 1) 350°; 2) 400°; 3) 450°; "Armco" Iron: 4) 350°; 5) 400°; Kh18N9T steel: 7) 350°; 8) 400°; 9) 450°.

Fig. 1a,b. Corrosion attack in Molten KOH vs NaOH (from Ref. 7)
